DANE COUNTY DEPARTMENT of PUBLIC WORKS, HIGHWAY and TRANSPORTATION

RFP NO. 108040 - ADDENDUM NO. 1

ENGINEERING SERVICES FOR BABCOCK & TENNEY DAM FAILURE ANALYSIS, STABILITY ANALYSIS, PERMANENT BENCHMARKS AND AN EMERGENCY ACTION PLAN

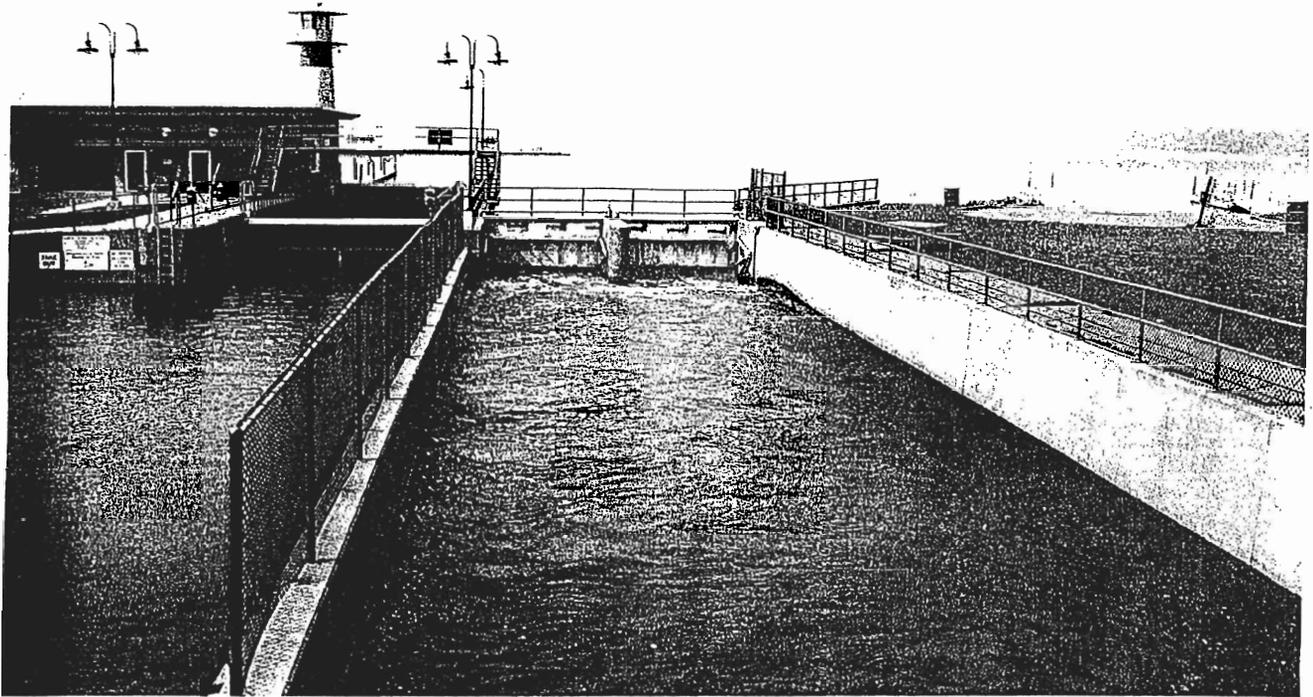
Photo 1 - View of dam from downstream. Two tainter gates on right of wall and lock on left
Photo 2 - View looking downstream from bridge over Sherman Avenue

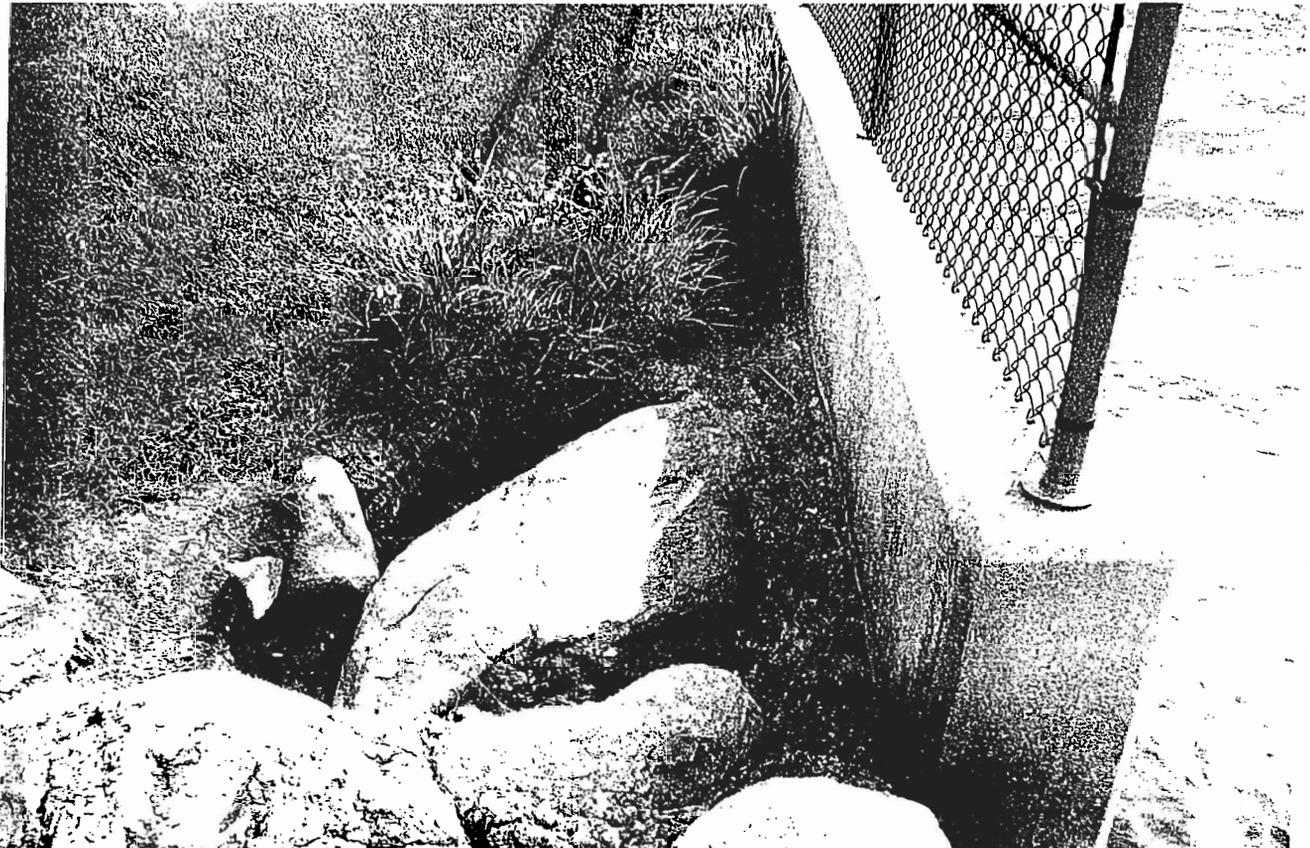
Photo 6 - View of upstream end of left retaining wall. Note erosion working its way behind wall

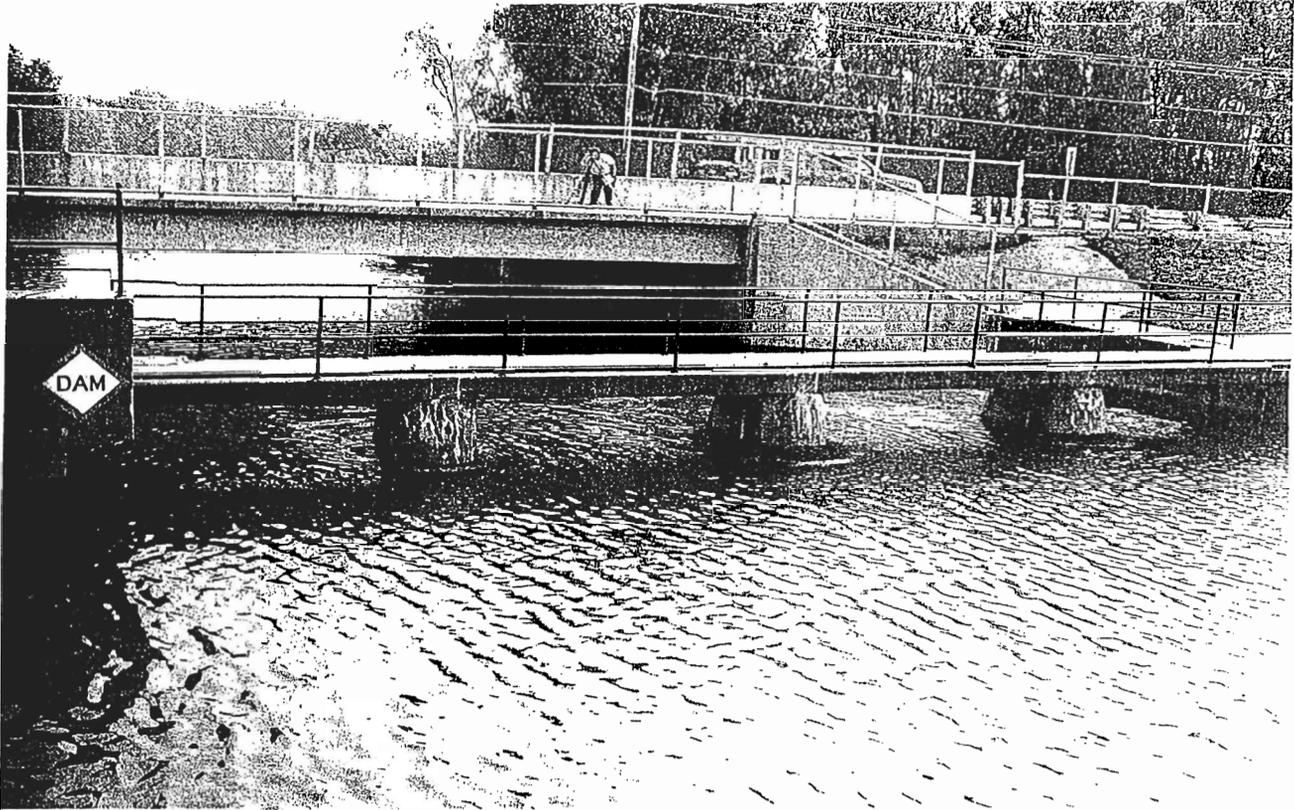
Photo 3 - View of piers/operator's deck from upstream

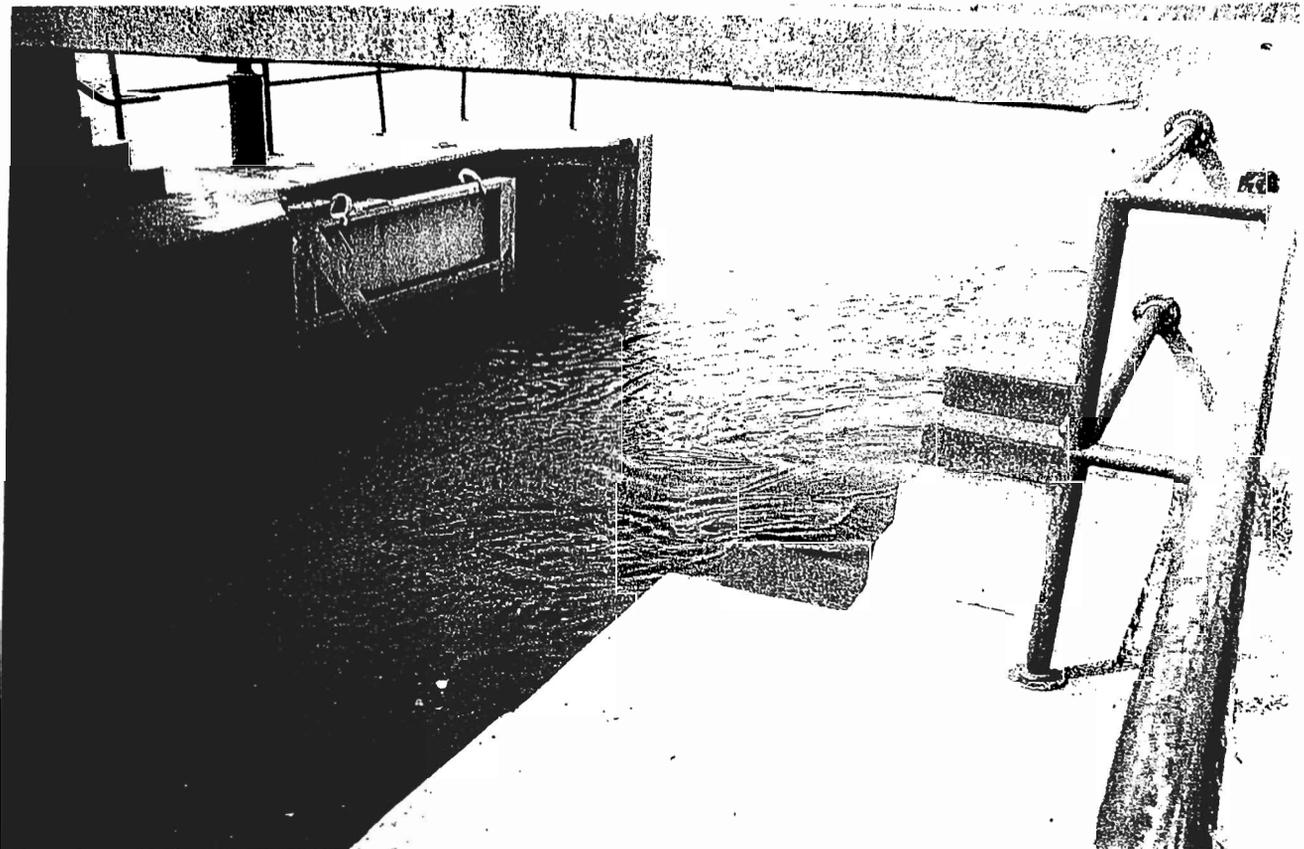
Photo 4 - View of lock portion of dam. Currently not operational

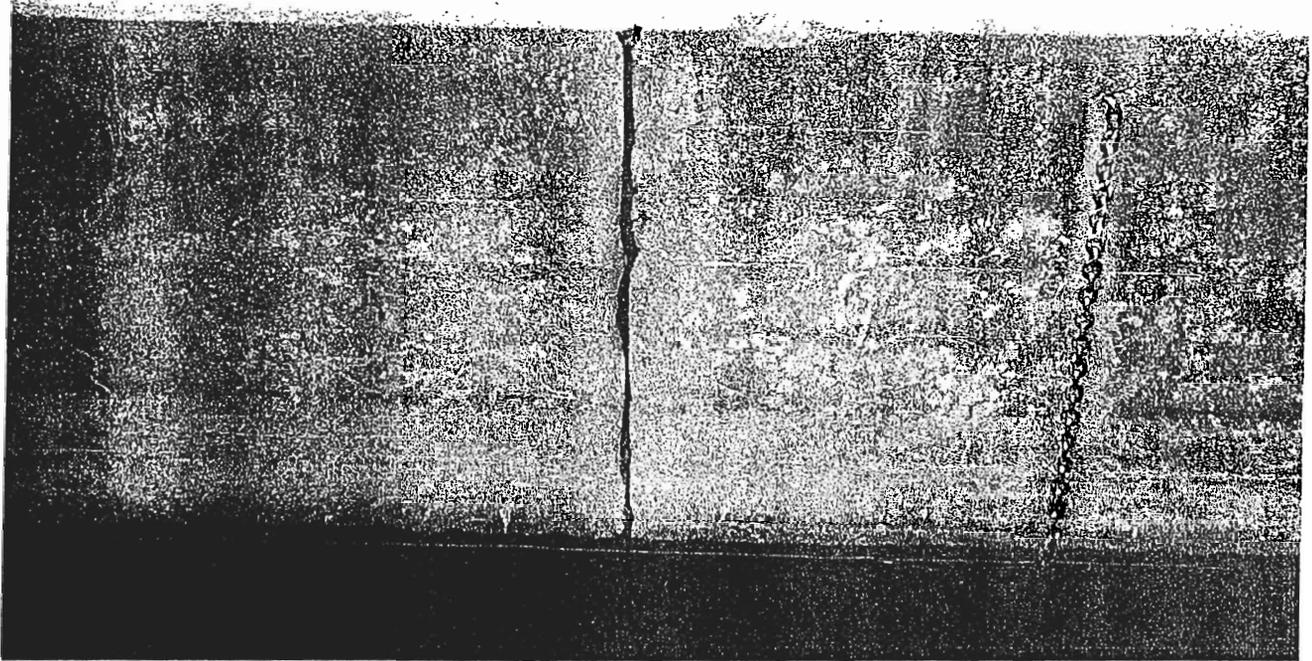
Photo 5 - View of cold joint in concrete (in lock). Fill joint with crack filler
