RFB NO. 318068

# **CONSTRUCTION DOCUMENTS PROJECT MANUAL**

DANE COUNTY DEPARTMENT OF PUBLIC WORKS,  
HIGHWAY AND TRANSPORTATION

## **REQUEST FOR BIDS NO. 318068 BUILDING DEMOLITIONS FORMER MESSNER BUILDING 1314-1326 EAST WASHINGTON AVENUE MADISON, WISCONSIN**

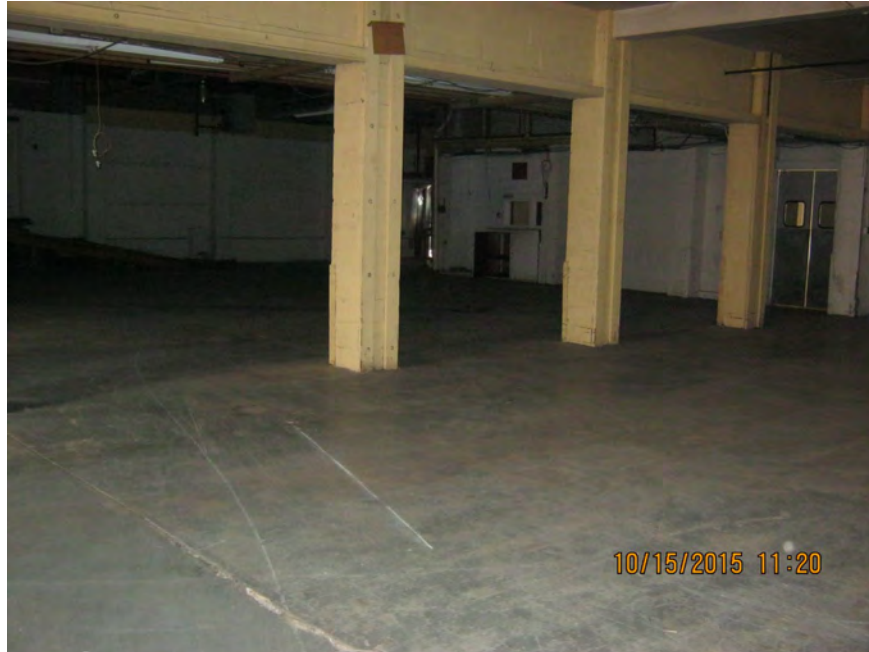
Photo 5: View of the warehouse area in the 1326 Washington Avenue building.

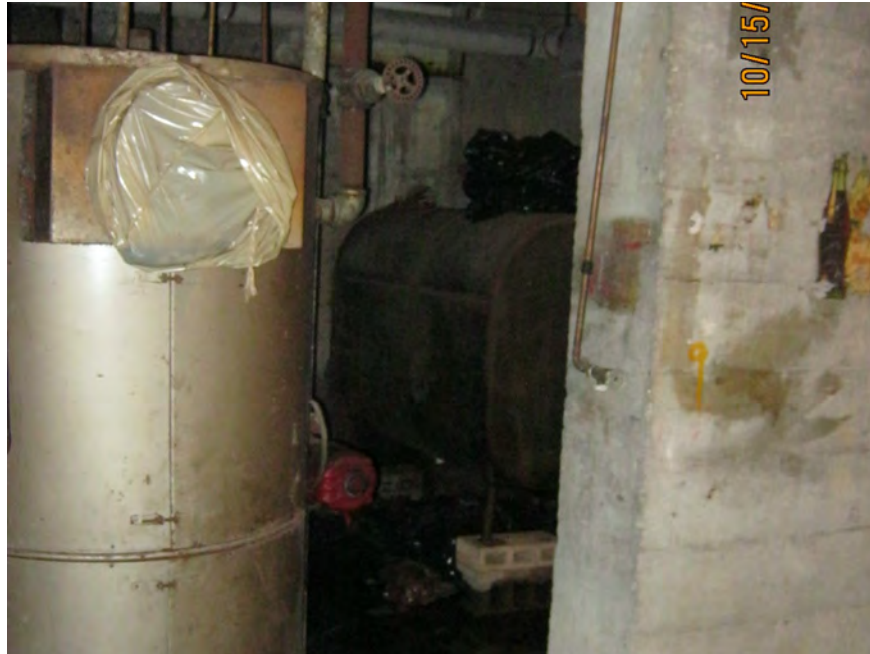
Photo 7: View of the AST observed in the basement of the 1326 Washington Avenue building

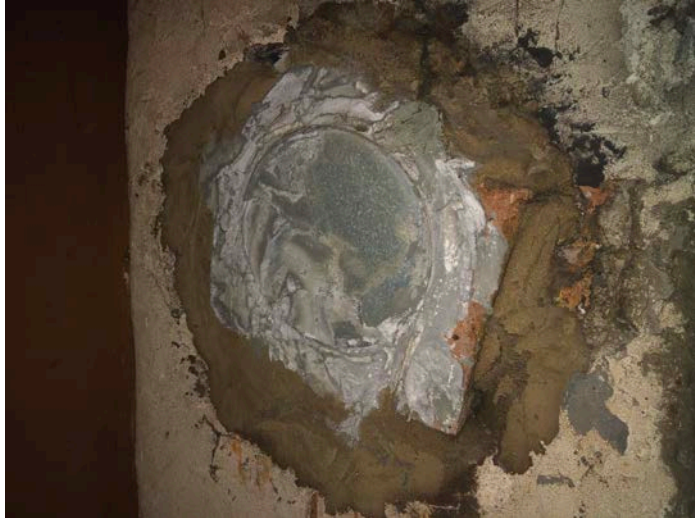
Asbestos Status  
4% Chrysotile

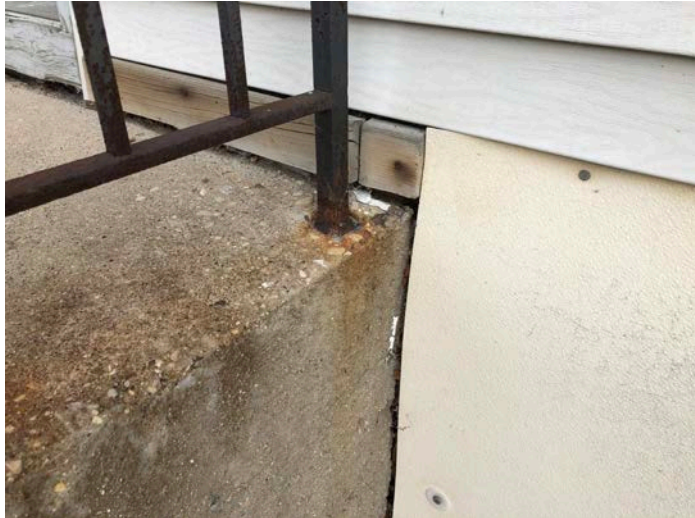
## EXTERIOR STAIRS CAULK (WHITE)

Room/Location  
Front Stairs

Asbestos Status  
3% Chrysotile

The above summarized materials must be properly removed from the building and disposed of prior to demolition

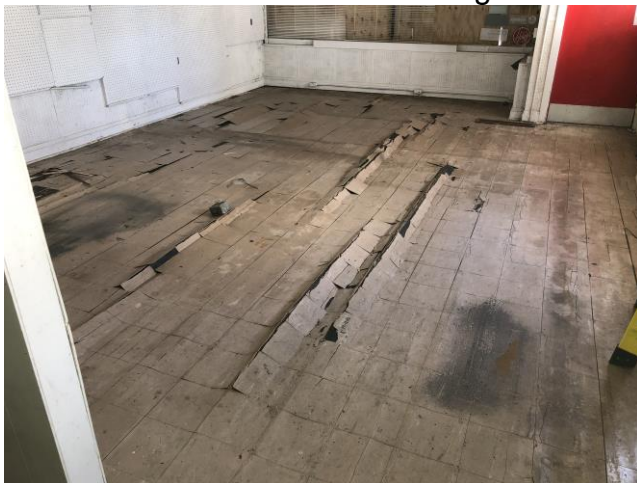
<u>Room/Location</u>	<u>Quantity</u>	<u>Asbestos Status</u>
Lobby	540 Sq. Ft. – Severely Damaged on Wood – Just Floor	5% Chrysotile

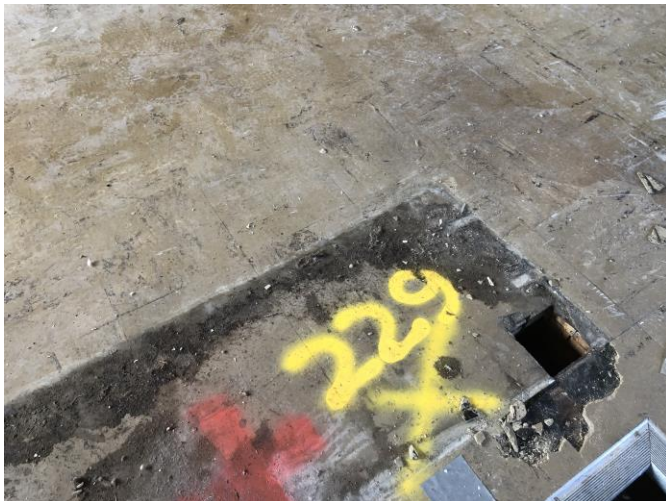
## 9" FLOOR TILE

<u>Room/Location</u>	<u>Quantity</u>	<u>Asbestos Status</u>
Back Showroom	480 Sq. Ft. on Concrete	10% Chrysotile
200	605 Sq. Ft. on Wood	10% Chrysotile
Foyer Hall	45 Sq. Ft. on Concrete	10% Chrysotile
Foyer	265 Sq. Ft. Under Carpet/ On Concrete	10% Chrysotile

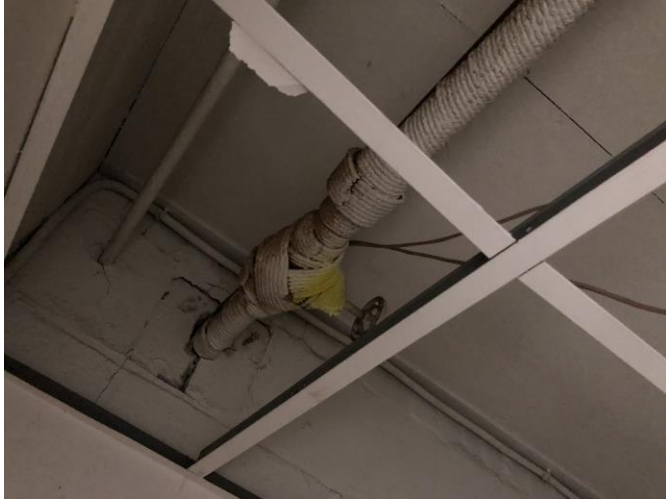
### TAR WRAP PIPE INSULATION - TPW

<u>Room/Location</u>	<u>Quantity</u>	<u>Asbestos Status</u>
Restroom 1	6 LF	10% Chrysotile
Back Showroom	4 LF	10% Chrysotile

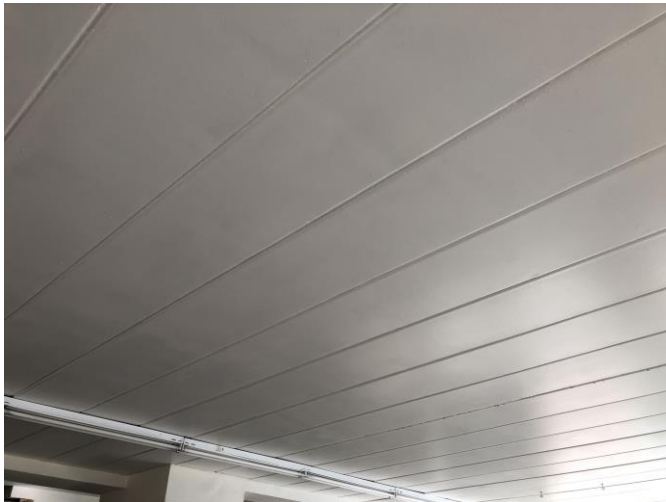
### SPANCRETE CAULK – MCLK(SP)

<u>Room/Location</u>	<u>Quantity</u>	<u>Asbestos Status</u>
Showroom/Exterior	1,650 LF	3% Chrysotile
Southeast Stairs

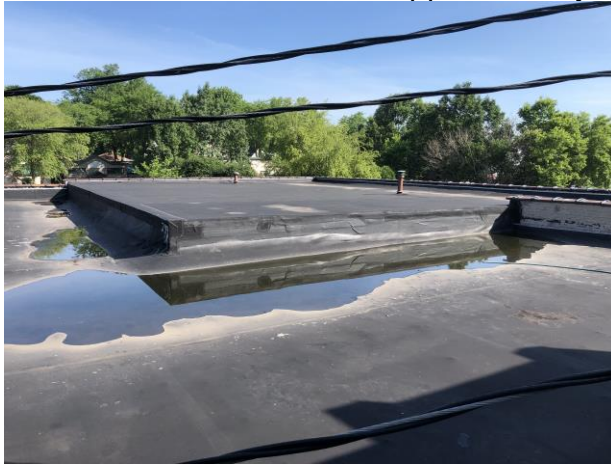
<u>Room/Location</u>	<u>Quantity</u>	<u>Asbestos Status</u>
Roof	Approximately 10,000 Sq. Ft.	3% Chrysotile

At the time of inspection, the above stated materials were assessed in a good condition. Non-friable ACM does not have to be removed prior to a normal demolition if it is not in poor condition prior to starting the demolition and is not likely to become friable during demolition activities. The resulting wastes can be handled as demolition material; contact the accepting landfill. If the demolition materials will be recycled, all ACM must be removed prior to the demolition. Furthermore, if the ACM becomes crumbled, pulverized or reduced to powder as a result of demolition practices, all materials must be treated as RACM including those demolition materials co-mingled with the RACM.
