DANE COUNTY PUBLIC WORKS
ENGINEERING DIVISION

DANE COUNTY SHERIFF'S OFFICE
SADDLEBROOK PROPERTY - 5656 ENCHANTED VIEW LANE
WAUNAKEE, WISCONSIN

FIGURE 1
SITE PLAN & BUILDING SIZE

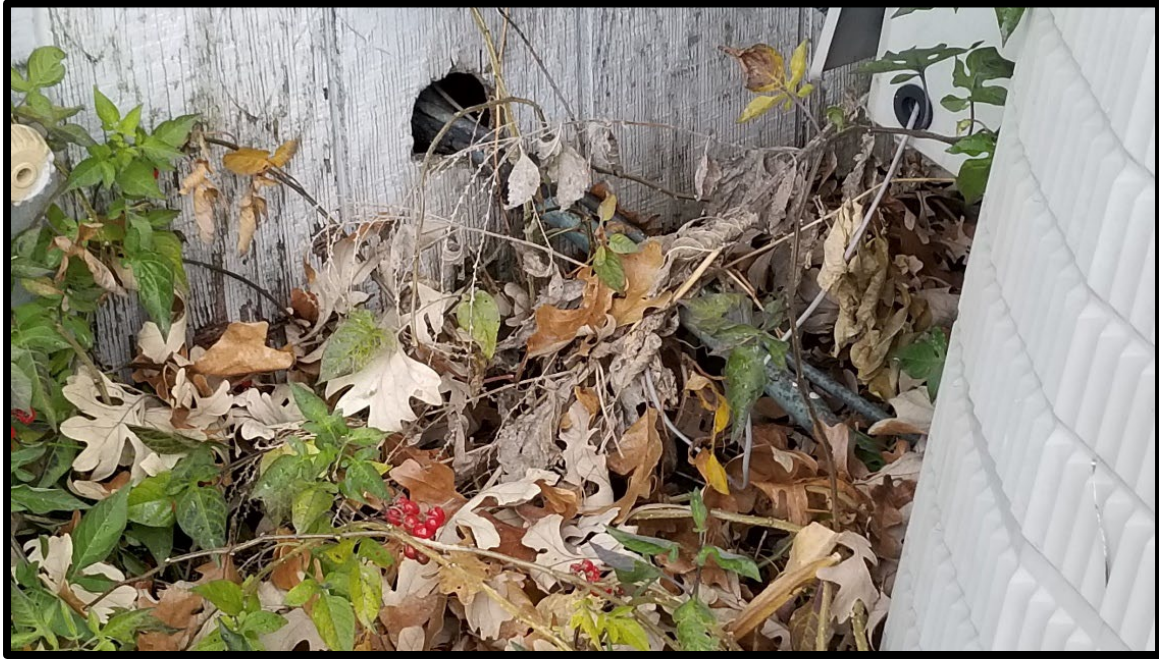
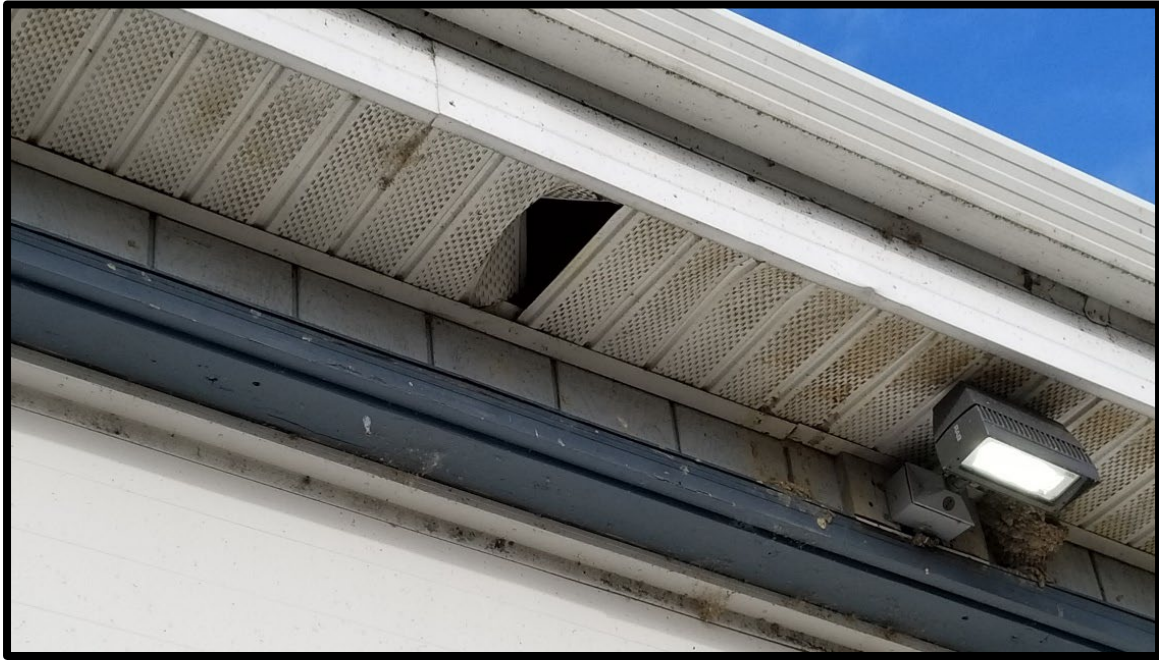
Typical examples of envelope repairs

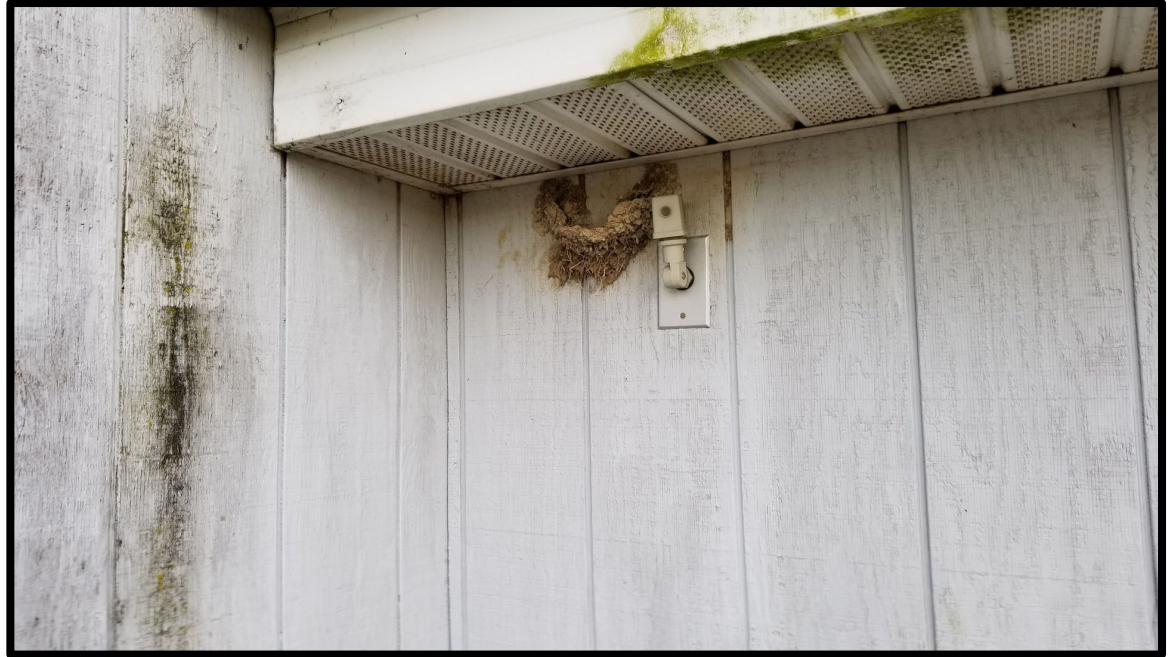
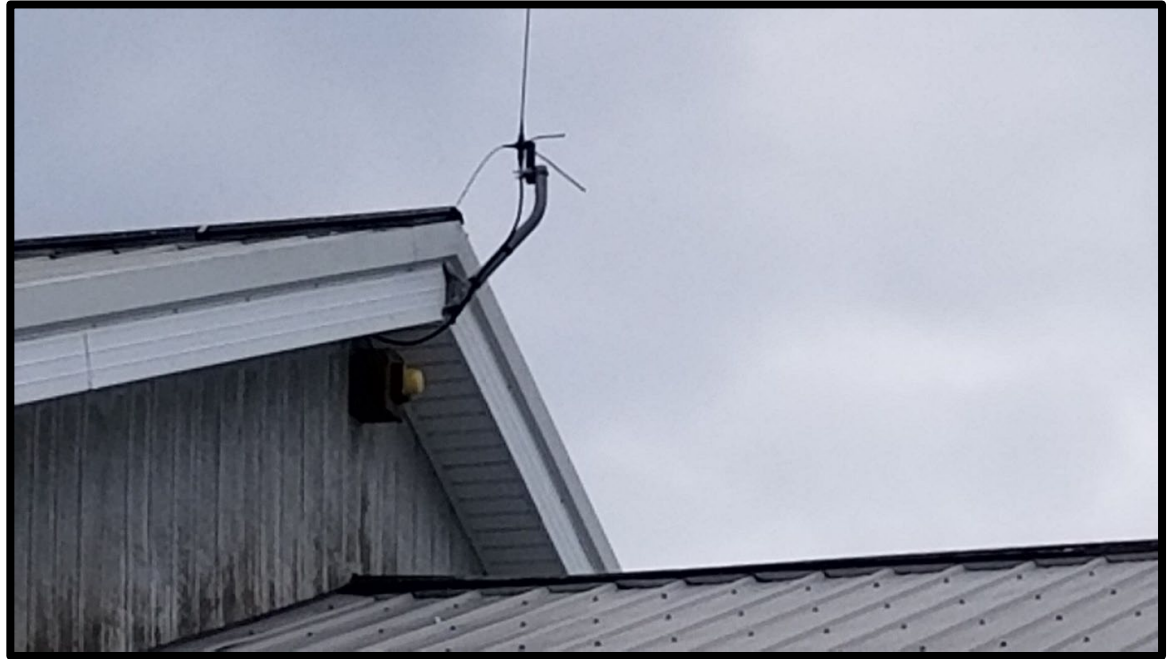
Devices to be demolished

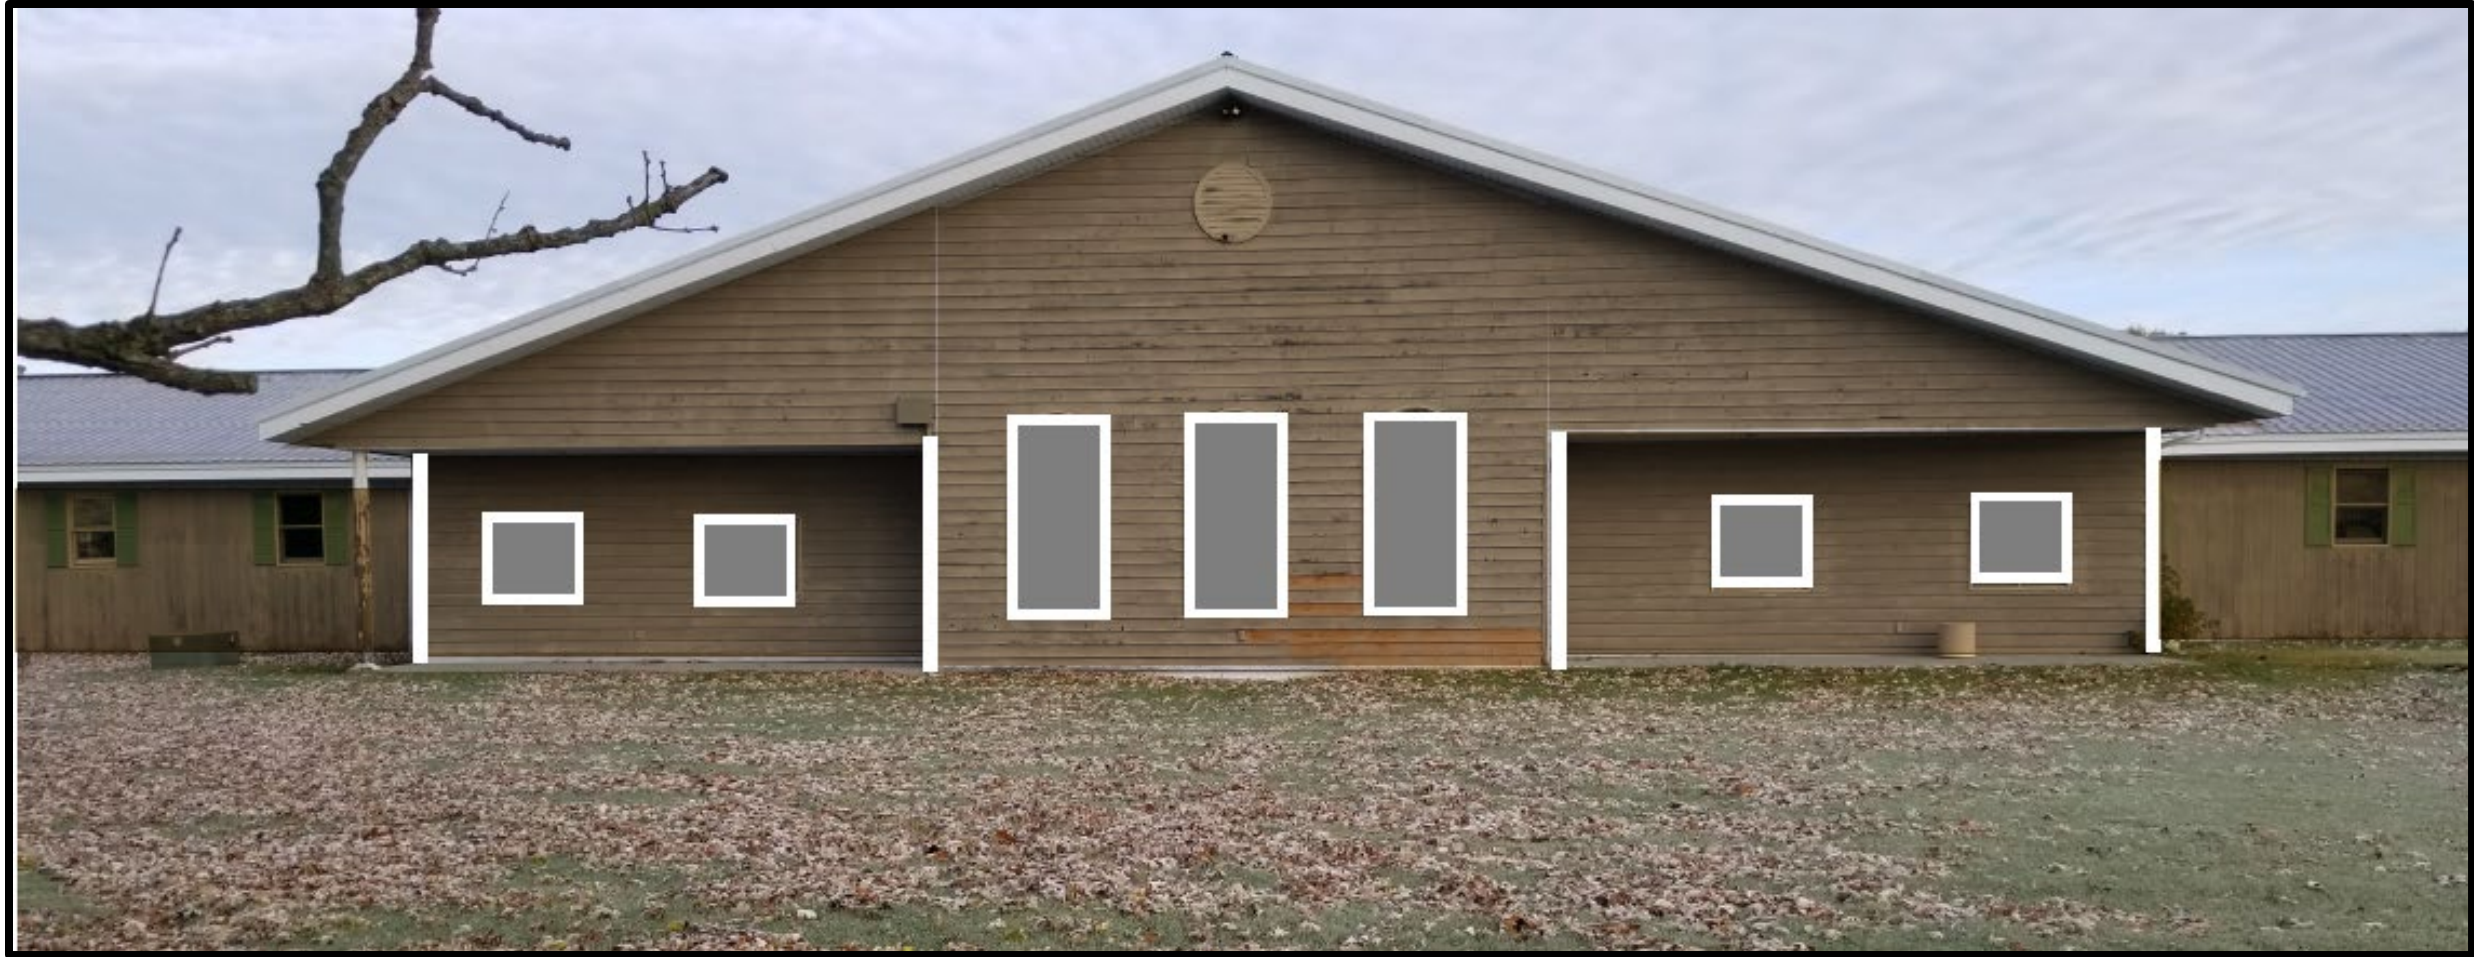
Base Bid:

- * Colorized version of south exposure
- * Entire building, same color except white trim around windows, doors & outside corners
- * All siding is oriented horizontally

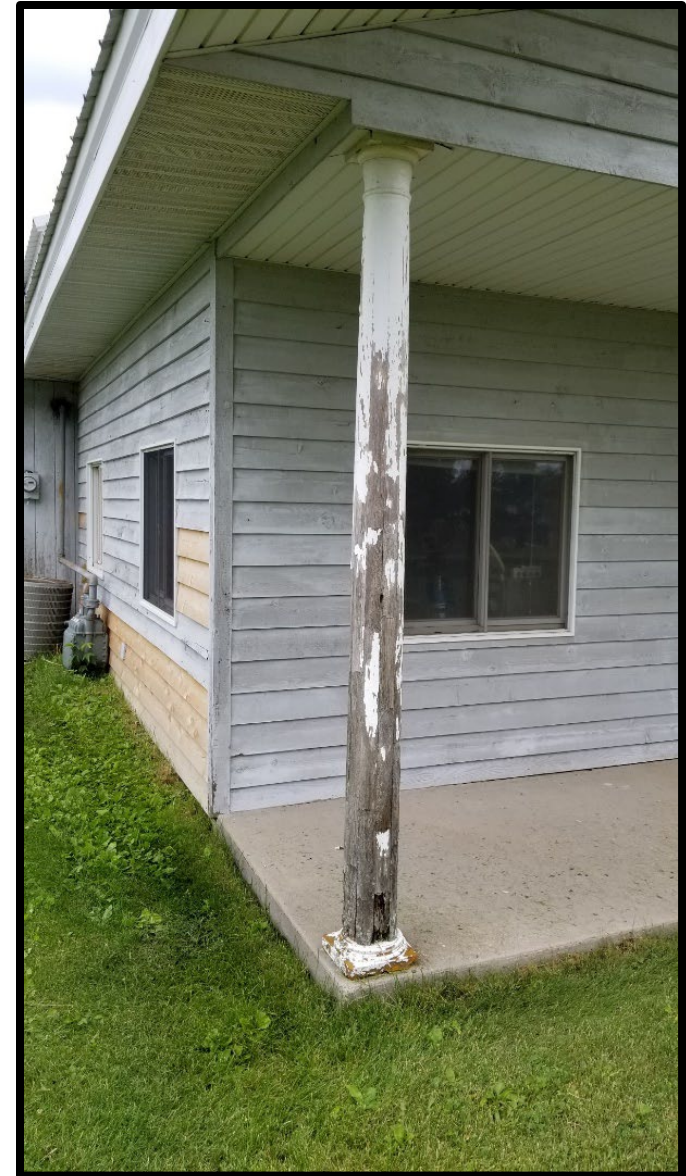
Base Bid: column to be replaced

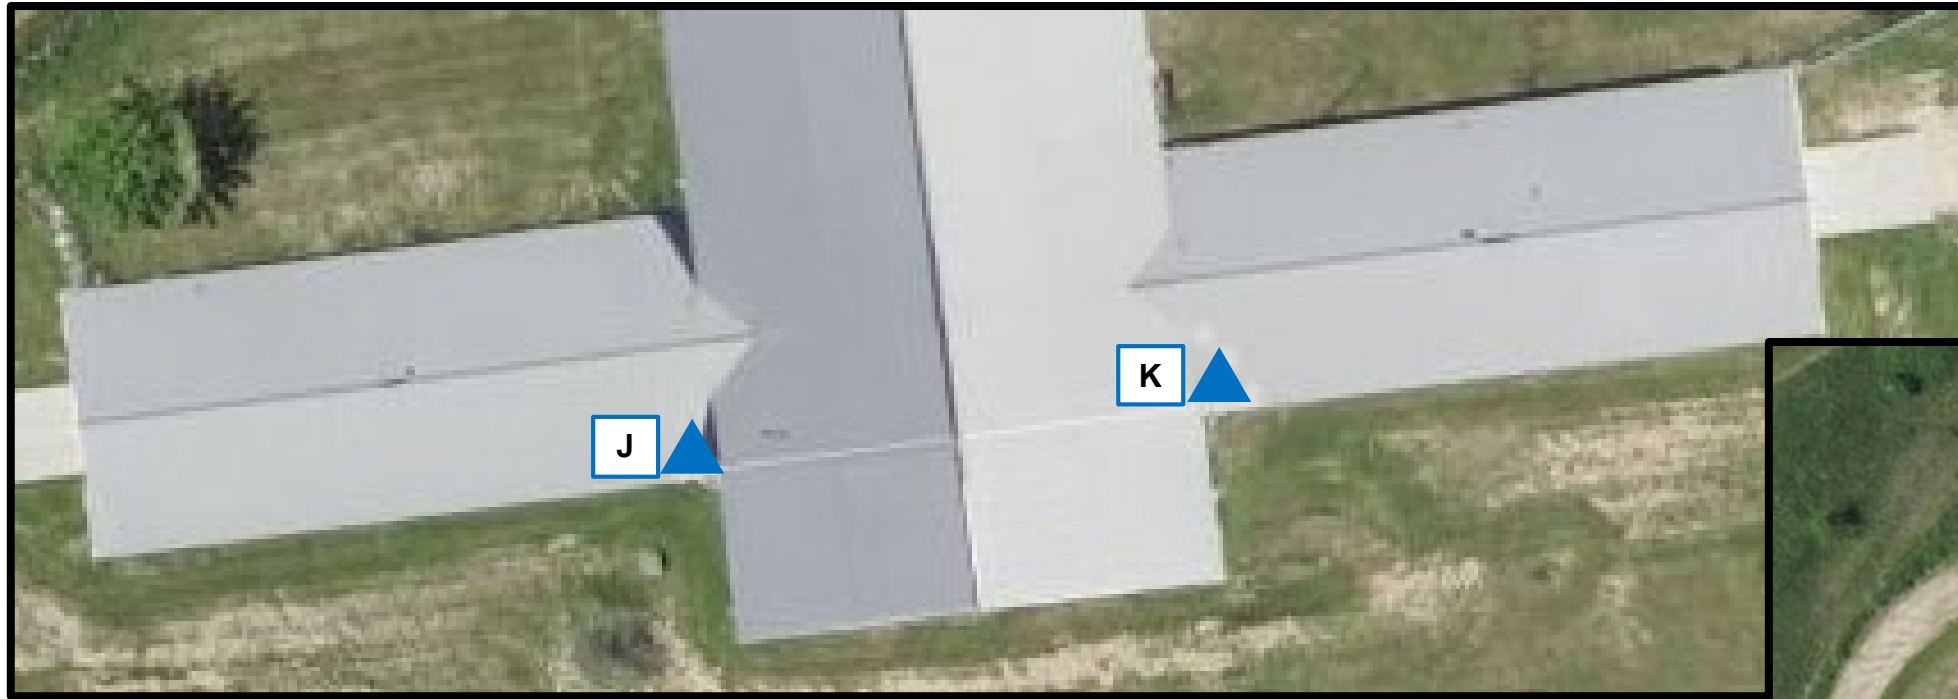
Alternate Bid 1: roof panel repairs at locations J & K

Approximate location of roof repairs (Alt Bid 1)
-

Roof panel repair designation

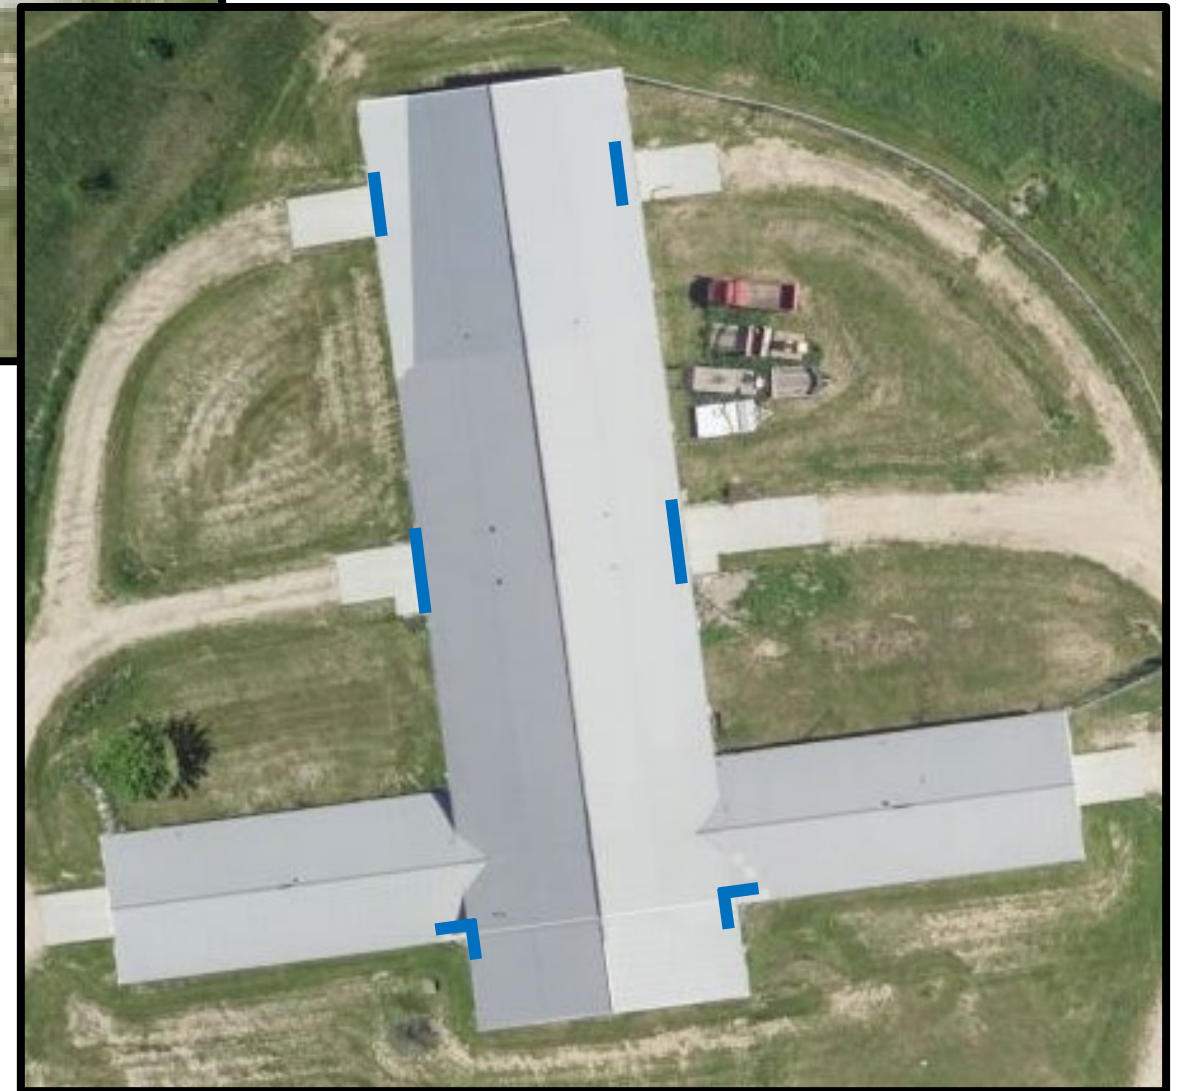
Alternate Bid 1: snow guard locations

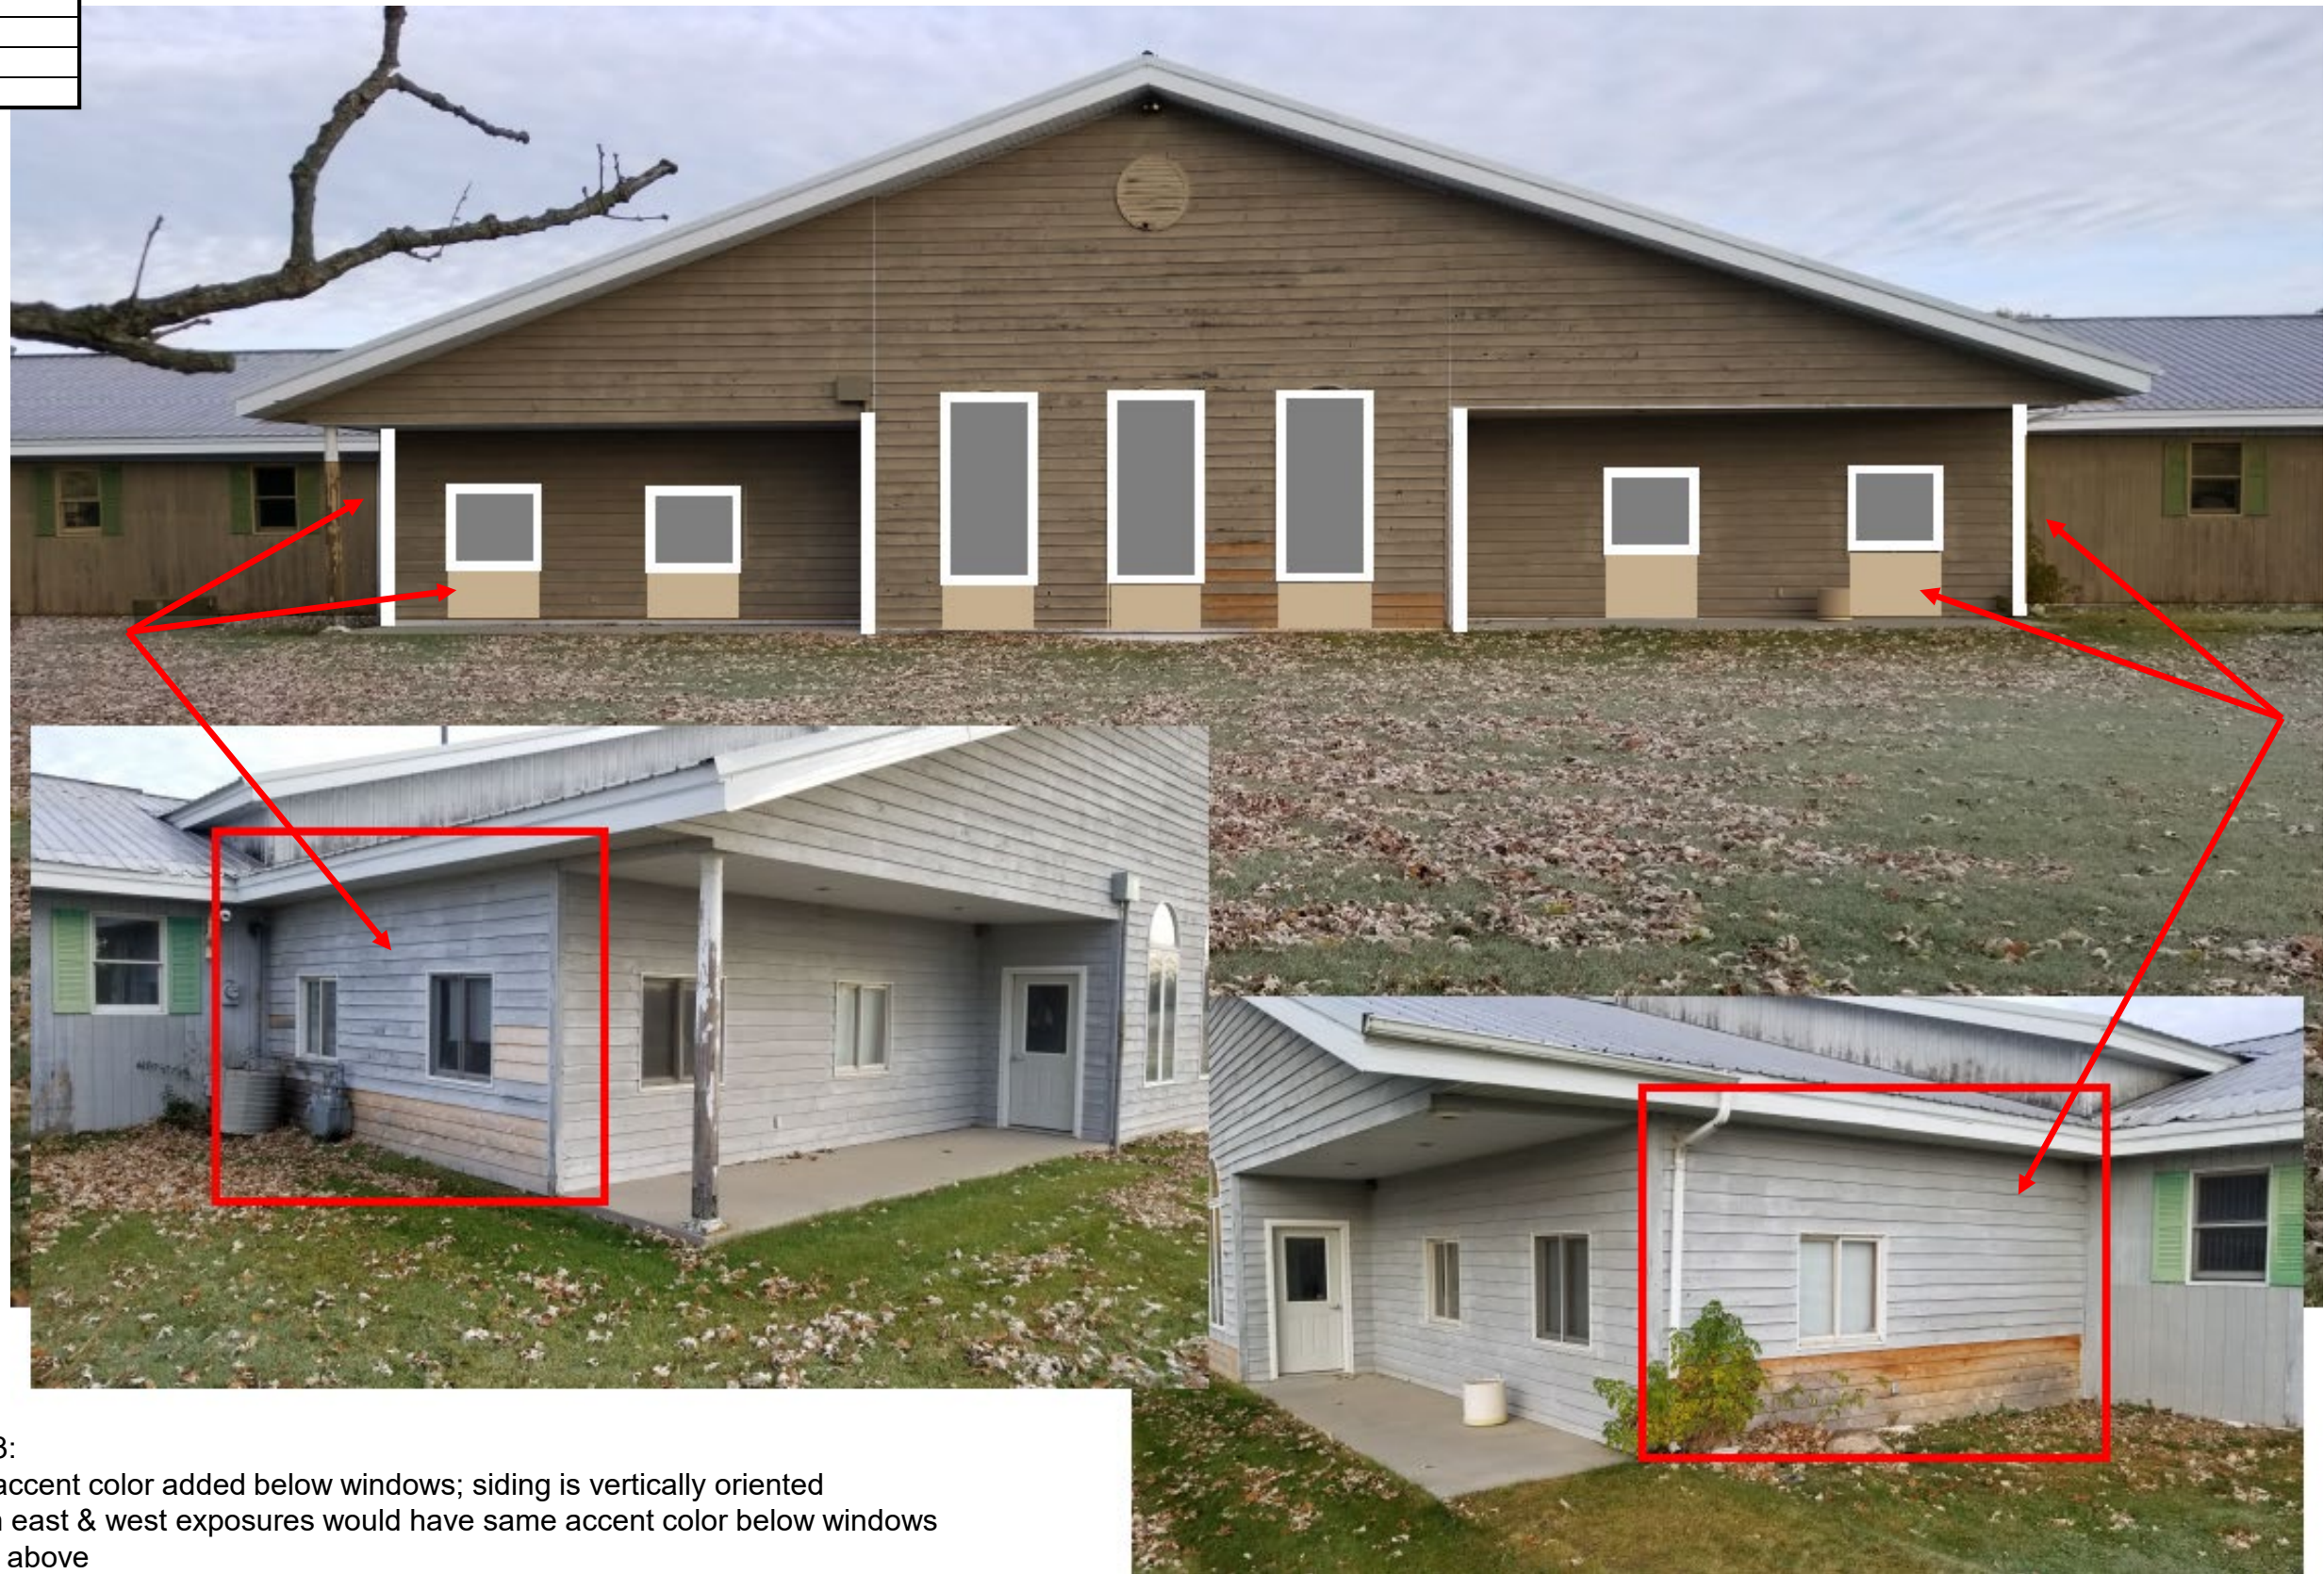
Alternate Bid 3:

- * Secondary accent color added below windows; siding is vertically oriented
- * Windows on east & west exposures would have same accent color below windows as depicted above
